INSPECTION

5. INSPECT KNOCK SENSOR

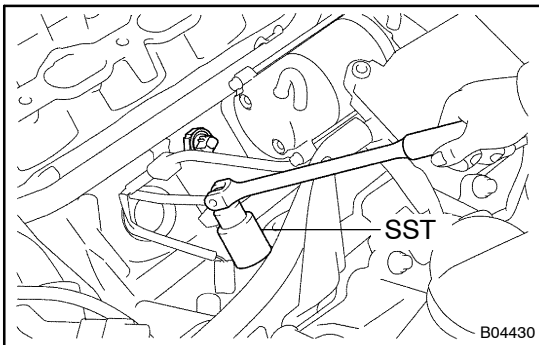
- (a) Disconnect the knock sensor connectors.
- (b) Using an ohmmeter, check that there is no continuity between the terminal and body.

If there is continuity, replace the sensor with SST.

Torque: 45 N·m (450 kgf·cm, 33 ft·lbf)
