## INSPECTION

### 1. INSPECT STEERING RACK

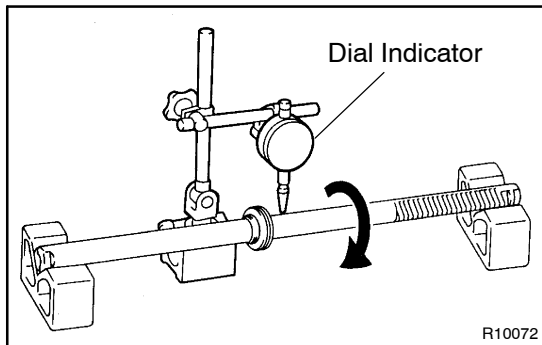
- (a) Using a dial indicator, check the rack for runout and for teeth wear and damage.

**Maximum runout: 0.03 mm (0.00 12 in.)**

- (b) Check the back surface for wear and damage.
