ON-VEHICLE INSPECTION

1. INSPECT REFRIGERANT VOLUME

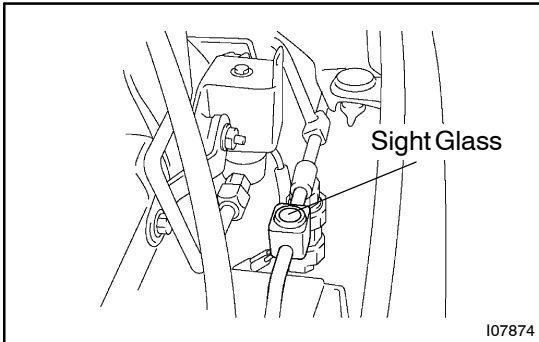
Observe the sight glass on the liquid tube.

- Running engine at 1,500 rpm
- Blower speed control switch at "HI" position
- A/C switch ON
- Temperature control dial at "COOL" position
- Fully open the doors

Item	Symptom	Amount of refrigerant	Remedy
1	Bubbles present in sight glass	Insufficient*	(1) Check for gas leakage with gas leak detector and repair if necessary (2) Add refrigerant until bubbles disappear
2	No bubbles present in sight glass	None, sufficient or too much	Refer item 3 and 4
3	No temperature difference between compressor inlet and outlet	Empty or nearly empty	(1) Check for gas leakage with gas leak detector and repair if necessary (2) Add refrigerant until bubbles disappear
4	Temperature between compressor inlet and outlet is noticeably different	Correct or too much	Refer to items 5 and 6
5	Immediately after air conditioner is turned off, refrigerant in sight glass stays clear	Too much	(1) Discharge refrigerant (2) Evacuate air and charge proper amount of purified refrigerant
6	When air conditioner is turned off, refrigerant foams and then stays clear	Correct	–

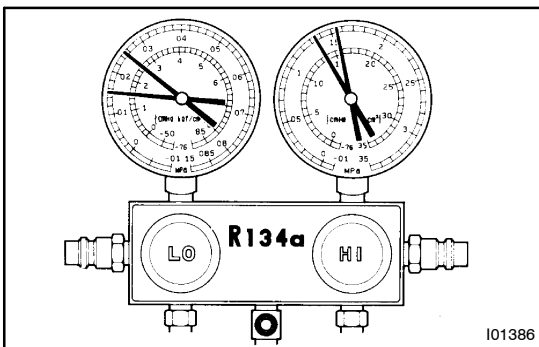
(1) Normally functioning refrigeration system.

Gauge reading:

Low pressure side:

0.15 – 0.25 MPa (1.5 – 2.5 kgf/cm²)

High pressure side:

1.37 – 1.57 MPa (14 – 15 kgf/cm²)

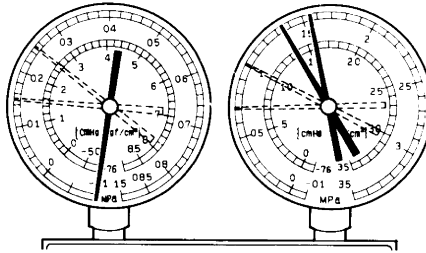
I01387

(2) Moisture present in refrigeration system.

Condition : Periodically cools and then fails to cool

Symptom seen in refrigeration system	Probable cause	Diagnosis	Remedy
During operation, pressure on low pressure side sometimes become a vacuum and sometime normal	Moisture entered in refrigeration system freezes at expansion valve orifice and temporarily stops cycle, but normal state is restored after a time when the ice melts	<ul style="list-style-type: none"> • Drier in oversaturated state • Moisture in refrigeration system freezes at expansion valve orifice and blocks circulation of refrigerant 	(1) Replace condenser (2) Remove moisture in cycle through repeatedly evacuating air (3) Charge proper amount of new refrigerant

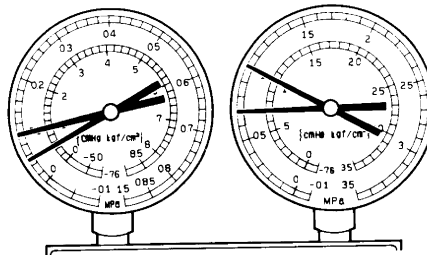
I01388

(3) Insufficient cooling

Condition: Insufficient cooling

Symptom seen in refrigeration system	Probable cause	Diagnosis	Remedy
<ul style="list-style-type: none"> • Pressure low on both low and high pressure sides • Bubbles seen in sight glass continuously • Insufficient cooling performance 	Gas leakage at some place in refrigeration system	<ul style="list-style-type: none"> • Insufficient refrigerant in system • Refrigerant leaking 	(1) Check for gas leakage with gas leak detector and repair if necessary (2) Charge proper amount of refrigerant (3) If indicated pressure value is near 0 when connected to gauge, create the vacuum after inspecting and repairing the location of the leak

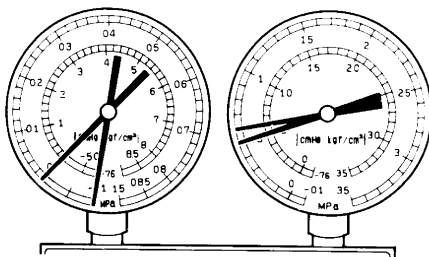
I01389

(4) Poor circulation of refrigerant

Condition: Insufficient cooling

Symptom seen in refrigeration system	Probable cause	Diagnosis	Remedy
<ul style="list-style-type: none"> Pressure low in both low and high pressure sides Frost on tube from condenser to unit 	Refrigerant flow obstructed by dirt in condenser	Condenser clogged	Replace condenser

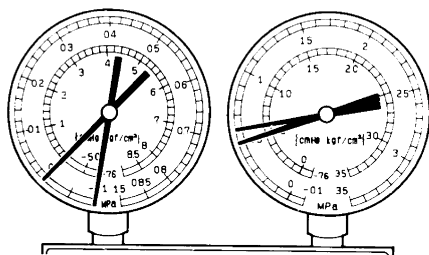
I01449

(5) Refrigerant does not circulate

Condition: Does not cool (Cools from time to time in some cases)

Symptom seen in refrigeration system	Probable cause	Diagnosis	Remedy
<ul style="list-style-type: none"> Vacuum indicated on low pressure side, very low pressure indicated on high pressure side Frost or dew seen on piping before and after condenser/drier or expansion valve 	<ul style="list-style-type: none"> Refrigerant flow obstructed by moisture or dirt in refrigeration system Refrigerant flow obstructed by gas leakage from expansion valve 	Refrigerant does not circulate	<ol style="list-style-type: none"> (1) Check expansion valve (2) Clean out dirt in expansion valve by blowing with air (3) Replace condenser (4) Evacuate air and charge new refrigerant to proper amount (5) For gas leakage from expansion valve, replace expansion valve

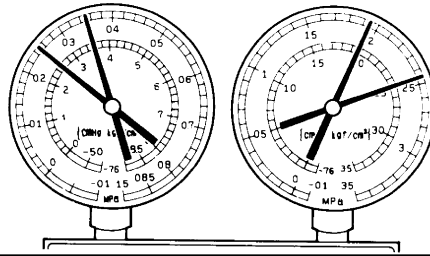
I01390

(6) Refrigerant overcharged or insufficient cooling of condenser

Condition: Insufficient cooling

Symptom seen in refrigeration system	Probable cause	Diagnosis	Remedy
S Pressure too high on both low and high pressure sides S No air bubbles seen through the sight glass even when the engine rpm is lowered	S Unable to develop sufficient performance due to excessive refrigeration system S Insufficient cooling of condenser	S Excessive refrigerant in cycle → refrigerant over charged S Condenser cooling → condenser fins clogged of condenser fan faulty	(1) Clean condenser (2) Check condenser fan motor operation (3) If (1) and (2) are in normal state, check amount of refrigerant Charge proper amount of refrigerant

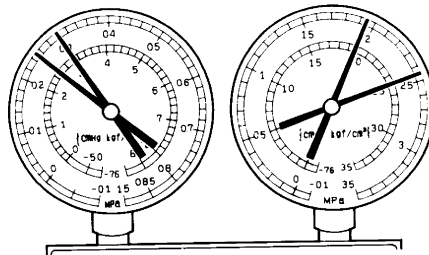
I01392

(7) Air present in refrigeration system

Condition: Insufficient cooling

NOTE : These gauge indications are shown when the refrigeration system has been opened and the refrigerant charged without vacuum purging.

Symptom seen in refrigeration system	Probable cause	Diagnosis	Remedy
S Pressure too high on both low and high pressure sides S The low pressure piping hot to touch S Bubbles seen in sight glass	Air entered in refrigeration system	S Air present in refrigeration system S Insufficient vacuum purging	(1) Check compressor oil to see if it is dirty or insufficient (2) Evacuate air and charge new refrigerant

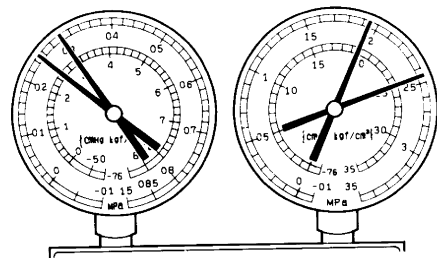
I01450

(8) Expansion valve improperly

Condition: Insufficient cooling

Symptom seen in refrigeration system	Probable cause	Diagnosis	Remedy
\$ Pressure too high on both low and high pressure sides \$ Frost or large amount of dew on piping on low pressure side	Trouble in expansion valve	\$ Excessive refrigerant in low pressure piping \$ Expansion valve opened too wide	Check expansion valve Replace if defective

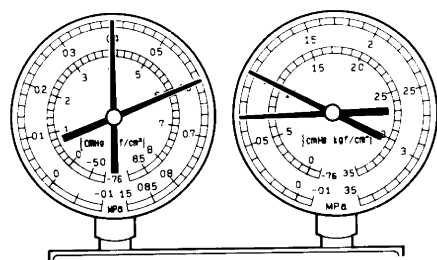
I01393

(9) Defective compression compressor

Condition : Does not cool

Symptom seen in refrigeration system	Probable cause	Diagnosis	Remedy
\$ Pressure too high on low and high pressure sides \$ Pressure too low on high pressure side	Internal leak in compressor	\$ Compression defective \$ Valve leaking or broken sliding parts	Repair or replace compressor

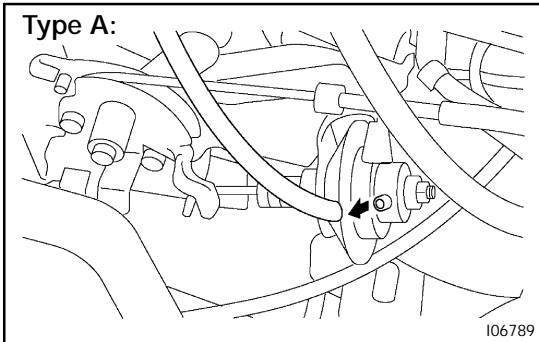
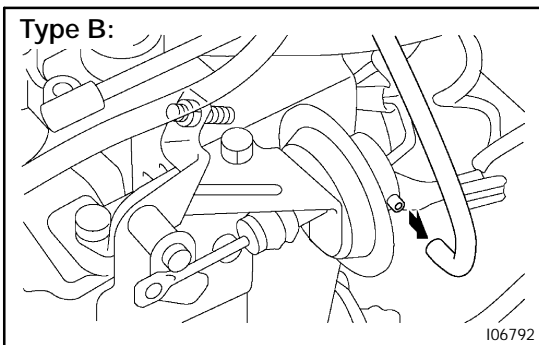
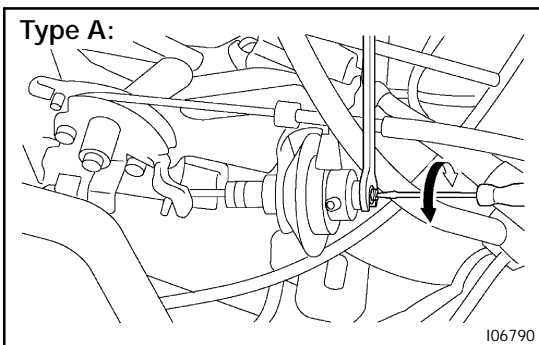
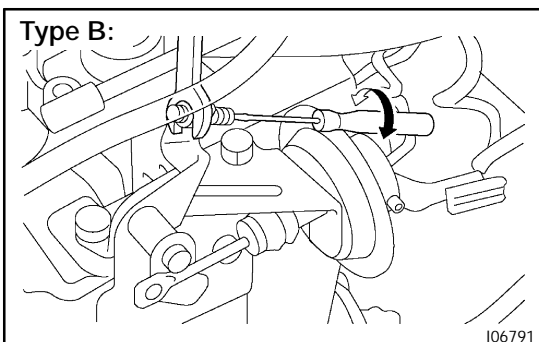
- (a) Perform in these conditions:
 - (1) Engine at normal operating temperature
 - (2) Injection timing set correctly
 - (3) Idle speed set correctly
- (b) Connect the tachometer.

- (c) Check idle-up speed.
 - (1) Disconnect the vacuum hose from the idle-up actuator
 - (2) Apply vacuum to idle-up actuator.
 - (3) Race the engine to 2,500 rpm for a few seconds, release the throttle and check the idle-up speed

Standard idle-up speed: 950 ± 50 rpm

If idle-up speed is not as specified, adjust the idle-up speed by turning the adjusting screw.

- (4) Race the engine to 2,500 rpm for few seconds.
- (5) Release the throttle and recheck the idle-up speed.
- (6) Connect the vacuum hose to idle-up actuator.
