FRONT A/C EVAPORATOR ON-VEHICLE INSPECTION

AC1T8-01

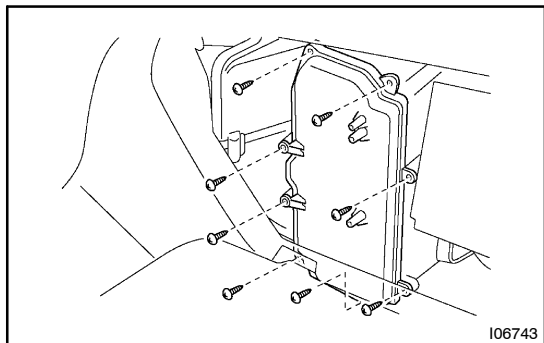
- (a) Remove these parts:
 - (1) Glove compartment door
 - (2) Lower No. 2 finish panel
(See page BO-127)
- (b) Remove the No.1 cooler cover.
 - (1) Disconnect the connector clamp.
 - (2) Remove the 8 screws and cover.
