MULTI DISPLAY TROUBLESHOOTING

LAND CRUISER (W/G) SUP (RM970E)

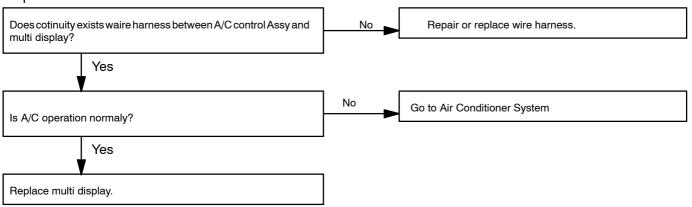
4 OUTER TEMPERATURE DISPLAY MALFUNCTION

- (a) Check that the battery positive voltage is 10 16 V.
- If voltage is not as specified, replace the battery.
- (b) Troubleshoot the outer temperature display as follows.

Inspect the connector on the wire harness side.
