DTC	B2798	Communication malfunction No.2
-----	-------	--------------------------------

CIRCUIT DESCRIPTION

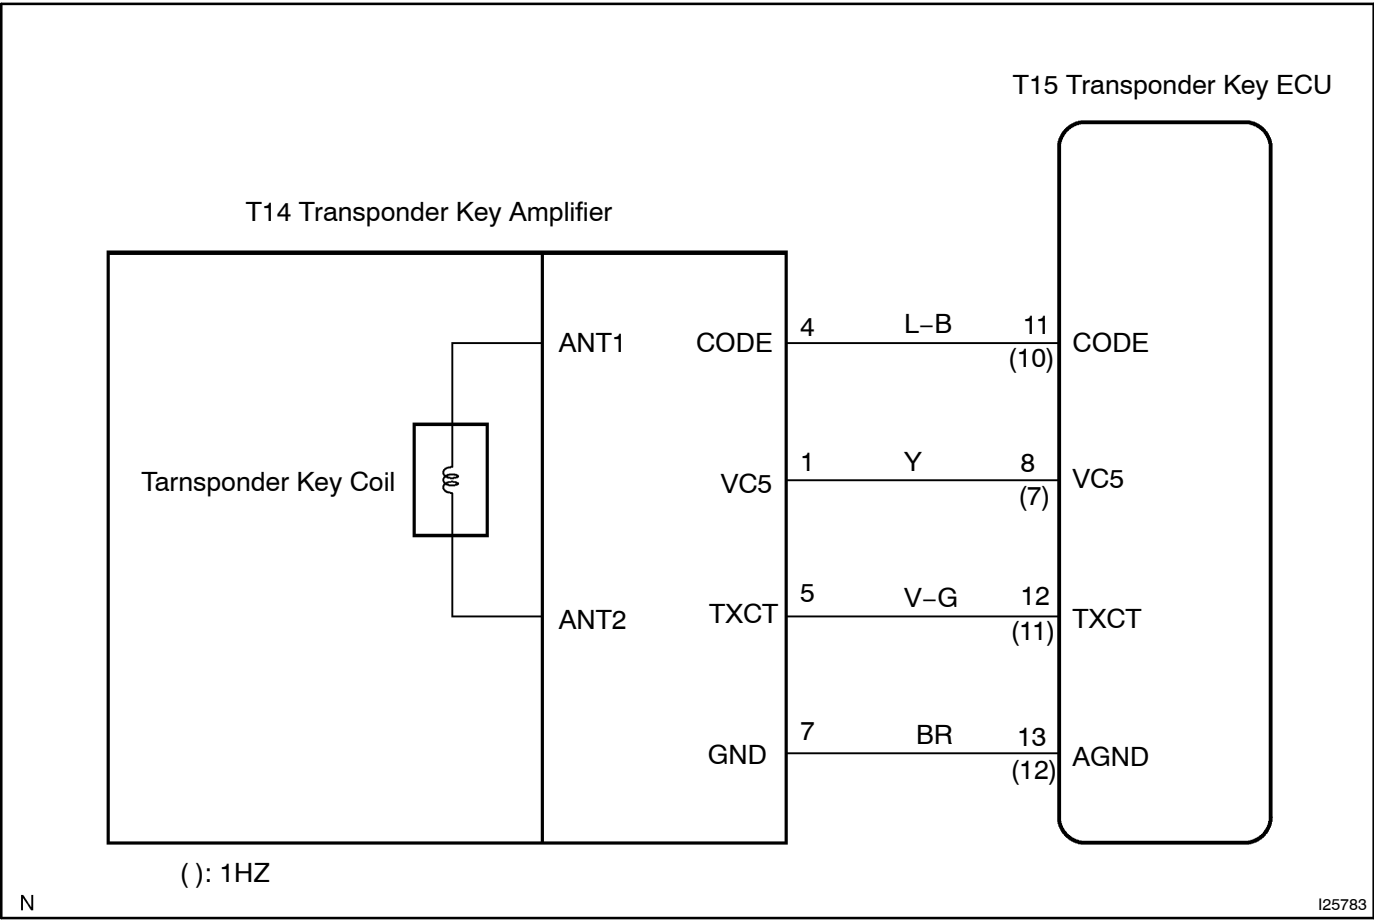
WIRING DIAGRAM

This code is detected when an error occurs, although the communication has been performed normally.  
(Example. Some noise is included in communication line.)

DTC No.	DTC Detecting Condition	Trouble Area
B2798	Communication error	<ul style="list-style-type: none"><li>• Key</li><li>• Transponder Key Amplifier with coil</li><li>• Wire harness</li><li>• Transponder key ECU</li></ul>

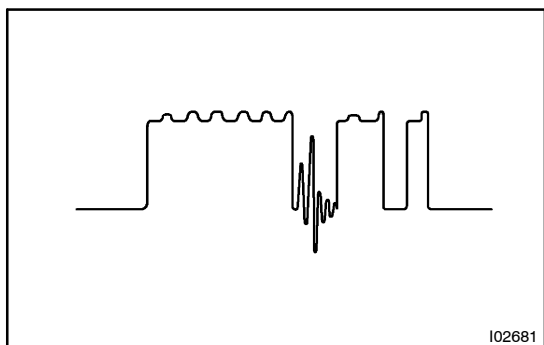
| 2 | <b>Noise check</b> |

Insert the already registered master key in the ignition key cylinder.

Using oscilloscope or the hand –held tester, check that noise is included in the signals sent to the CODE terminal of the Transponder key ECU.

**OK:****No noise is detected.****NG****Try to find the cause of the noise and remove it.****OK**
